# Langford Village footways and shared-use links

5K Health Route scheme implementation

This report was prepared by Richard Kingshott (LVCA Highways and Development) and examines the Health Route Scheme Implementation and the subsequent issues arising from the scheme.

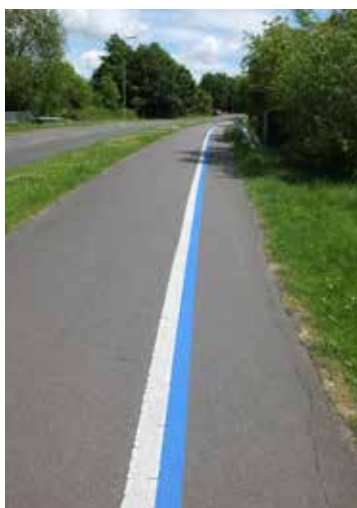
## Adjacent cycleway/footway routes

- Length of line laid 100/150mm adjacent to Marking 1049B: 907.5 metres
- Length of line laid 100/150mm opposite to Marking 1049B: 118 metres

In all these cases the presence of the additional line has at best compromised the legality of these sections of link and where no Marking 1049B is visible has rendered them illegal.

*The only marking permitted within an adjacent use facility or link is governed by the Traffic Signs and General Directions Act 2016. Only a white longitudinal marking to Diagram 1049B 150mm wide (or greater) is permitted. The marking can be laid on a coloured surface but there is no reference permitting a line of another colour to be laid adjacent to or parallel with this line.*

However in order to achieve this now all adjacent Health Route markings would have to be removed and either relocated to the side or a better solution found. The total length of blue line that would require removal is **1693.5 metres**.

The adjacent blue line cannot remain in its present location as it would cause confusion due to the routes new legal status and user understanding.

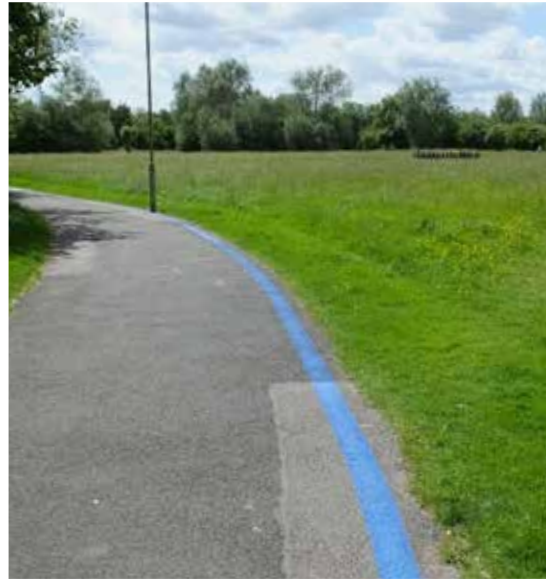
- Length of line laid on LHS of facility:  
233 metres
- Length of line laid on RHS of facility:  
776 metres

The presence of the line along these sections has visually narrowed them. No line markings are permitted along such routes. The lines have added to the 'street' clutter and given their colour are visually intrusive.

*\*No markings are required in a shared used facility as indicated within the Department for Transport Note 1/12 (September 2012). Coloured surfacing is permitted but not recommended and there is no reference permitting a line of any colour to be laid along such routes.*
